“Thermal imaging camera shows how Thermilate Warmcoat Advanced reduces room’s heat going out through a wall thereby making the room warmer with less heat wasted”

House location: Dublin. Built 1904, No wall insulation, north facing, usually cold, upstairs bedroom, Test done Dec 2009.

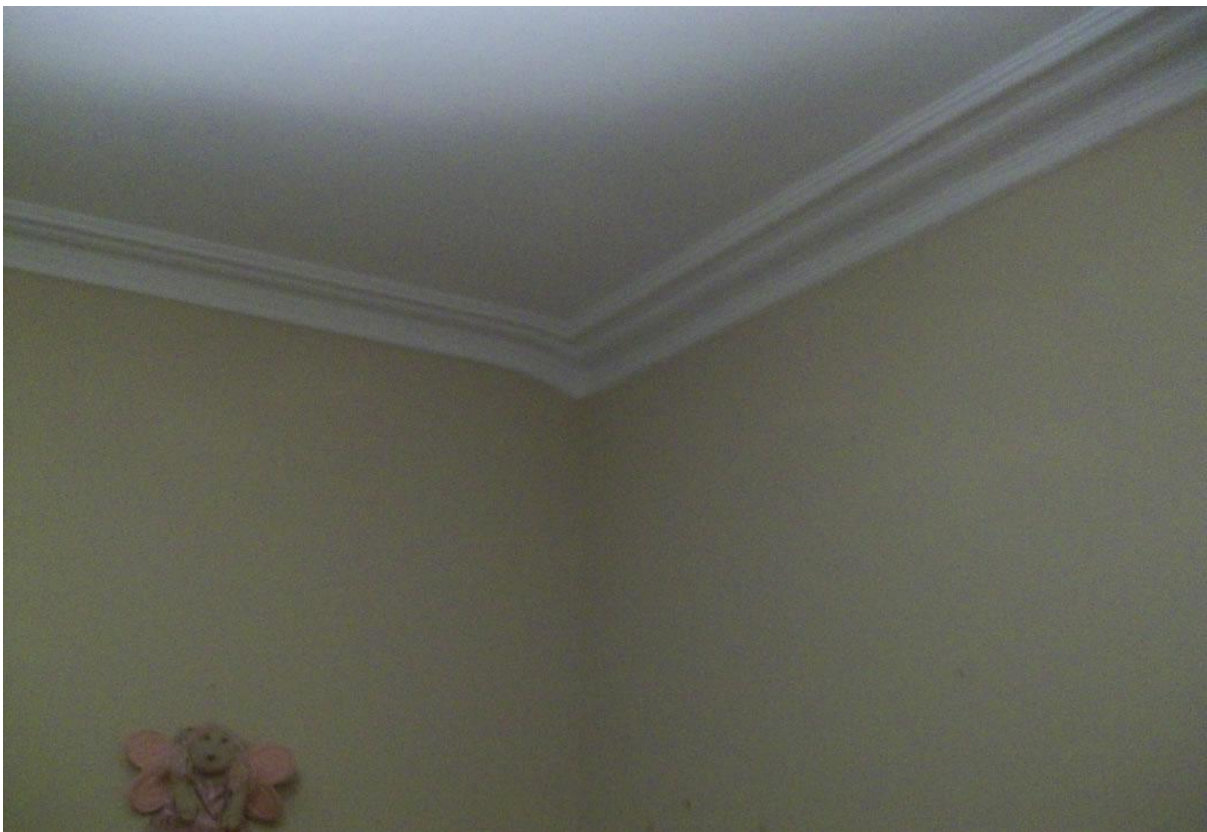
Picture No 1

Shows upper section of wall and ceiling with moulding before any Thermilate applied.

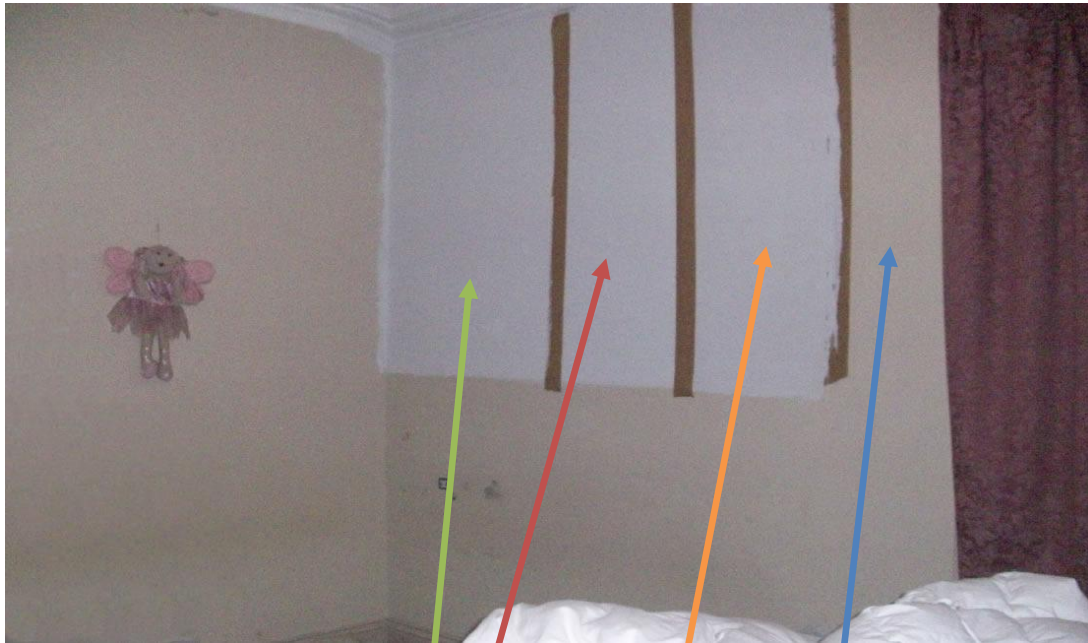
Picture No 2

One coat of Thermilate insulating paint was rolled on to about 2m² section on top left. When dry, it was divided into 3 sections which would receive different numbers of coats.

The far left section recd 3 coats total

The centre section recd 2 coats total

The right section recd only the one coat (first coat)

Section to the right of that (to left of curtain) was left unpainted.

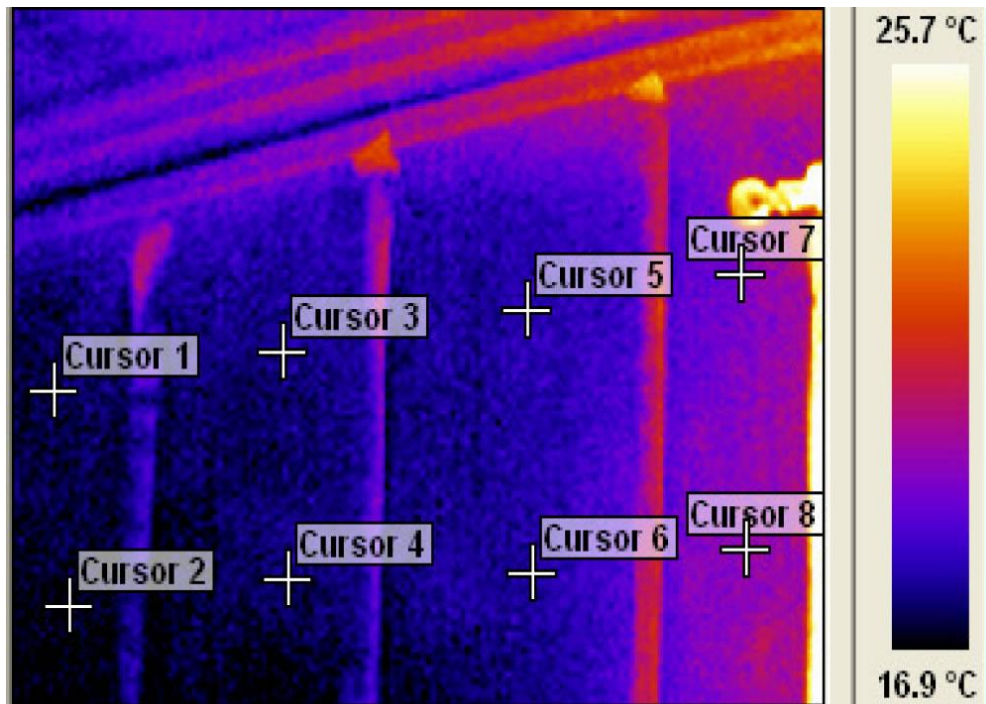
Picture No 3

1 Cursor 1&2 = 17.3°C & 17.1°C
2 Cursor 3&4 = 17.7°C & 17.8°C
3 Cursor 5&6 = 18.1°C & 17.9°C
4 Cursor 7&8 = 19.4°C & 19.8°C

Shows the difference in wall temperature between each of the 3 painted sections as well as the unpainted section to the right of them.

The lowest reading on far left shows lowest wall temperature which was covered by 3 coats of Thermilate, with slightly higher wall temperature readings for centre and right sections which received 2 and 1 coat of Thermilate respectively.

Note: The unpainted section on the right... it shows the highest wall temperature which means that a lot of the room's heat simply 'soaked' into the wall and out. **Or** to put it another way, the sections painted with the Thermilate show cooler wall temperature because a lot of the room's heat was reflected back into the room rather than escaping into and out through the wall.

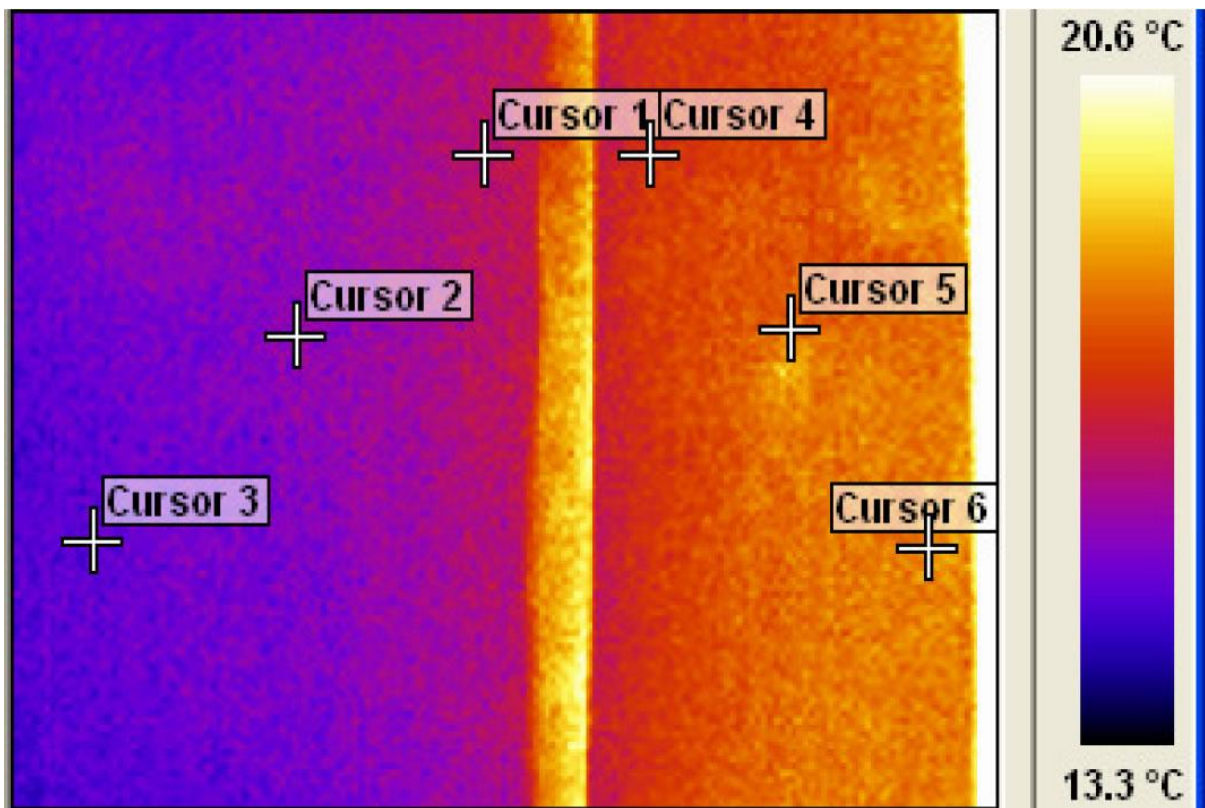
Picture no 4

Shows the large difference in the wall temperature between the section painted with only one coat of Thermilate and the section which received no Thermilate at all on the right.

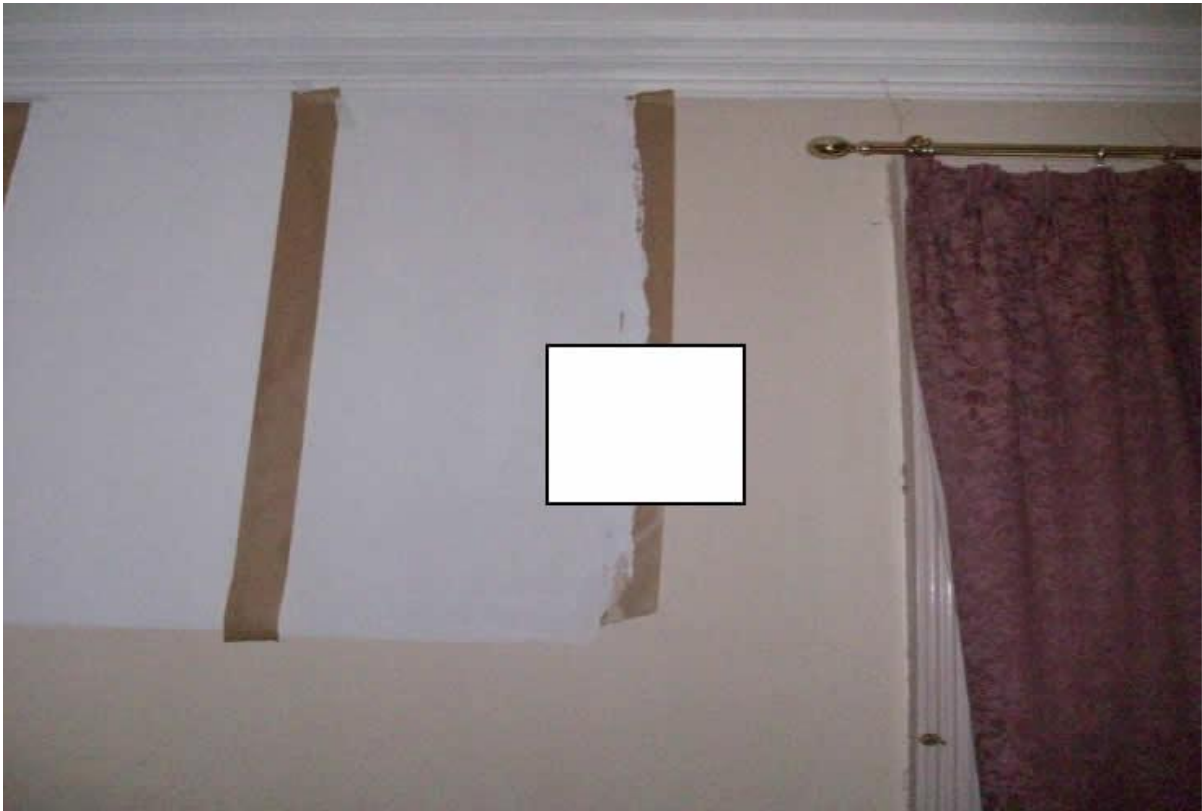
Picture No 5

Shows ordinary photo of the section beside the curtain which was not painted at all, and the section beside it which received only one coat of Thermilate.
